Engineering Geology
Technical Feasibility Study
Makushin Geothermal Power Project
Unalaska, Alaska

A Report Submitted to
Alaska Power Authority

Public Data File **86-60**

SEPTEMBER 1986

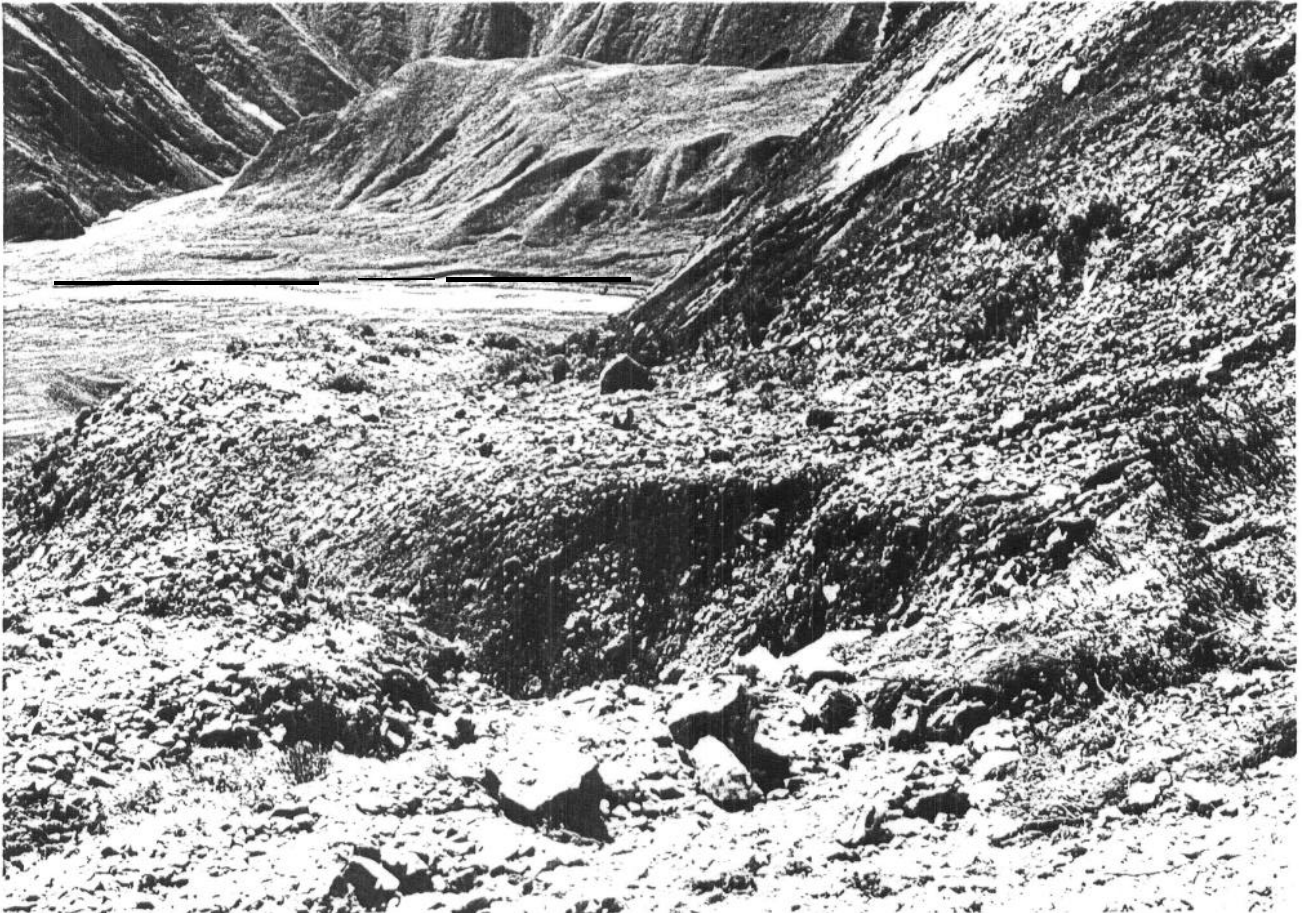
Figure 2. Road wash-out. Location shown on Figure 1 above.

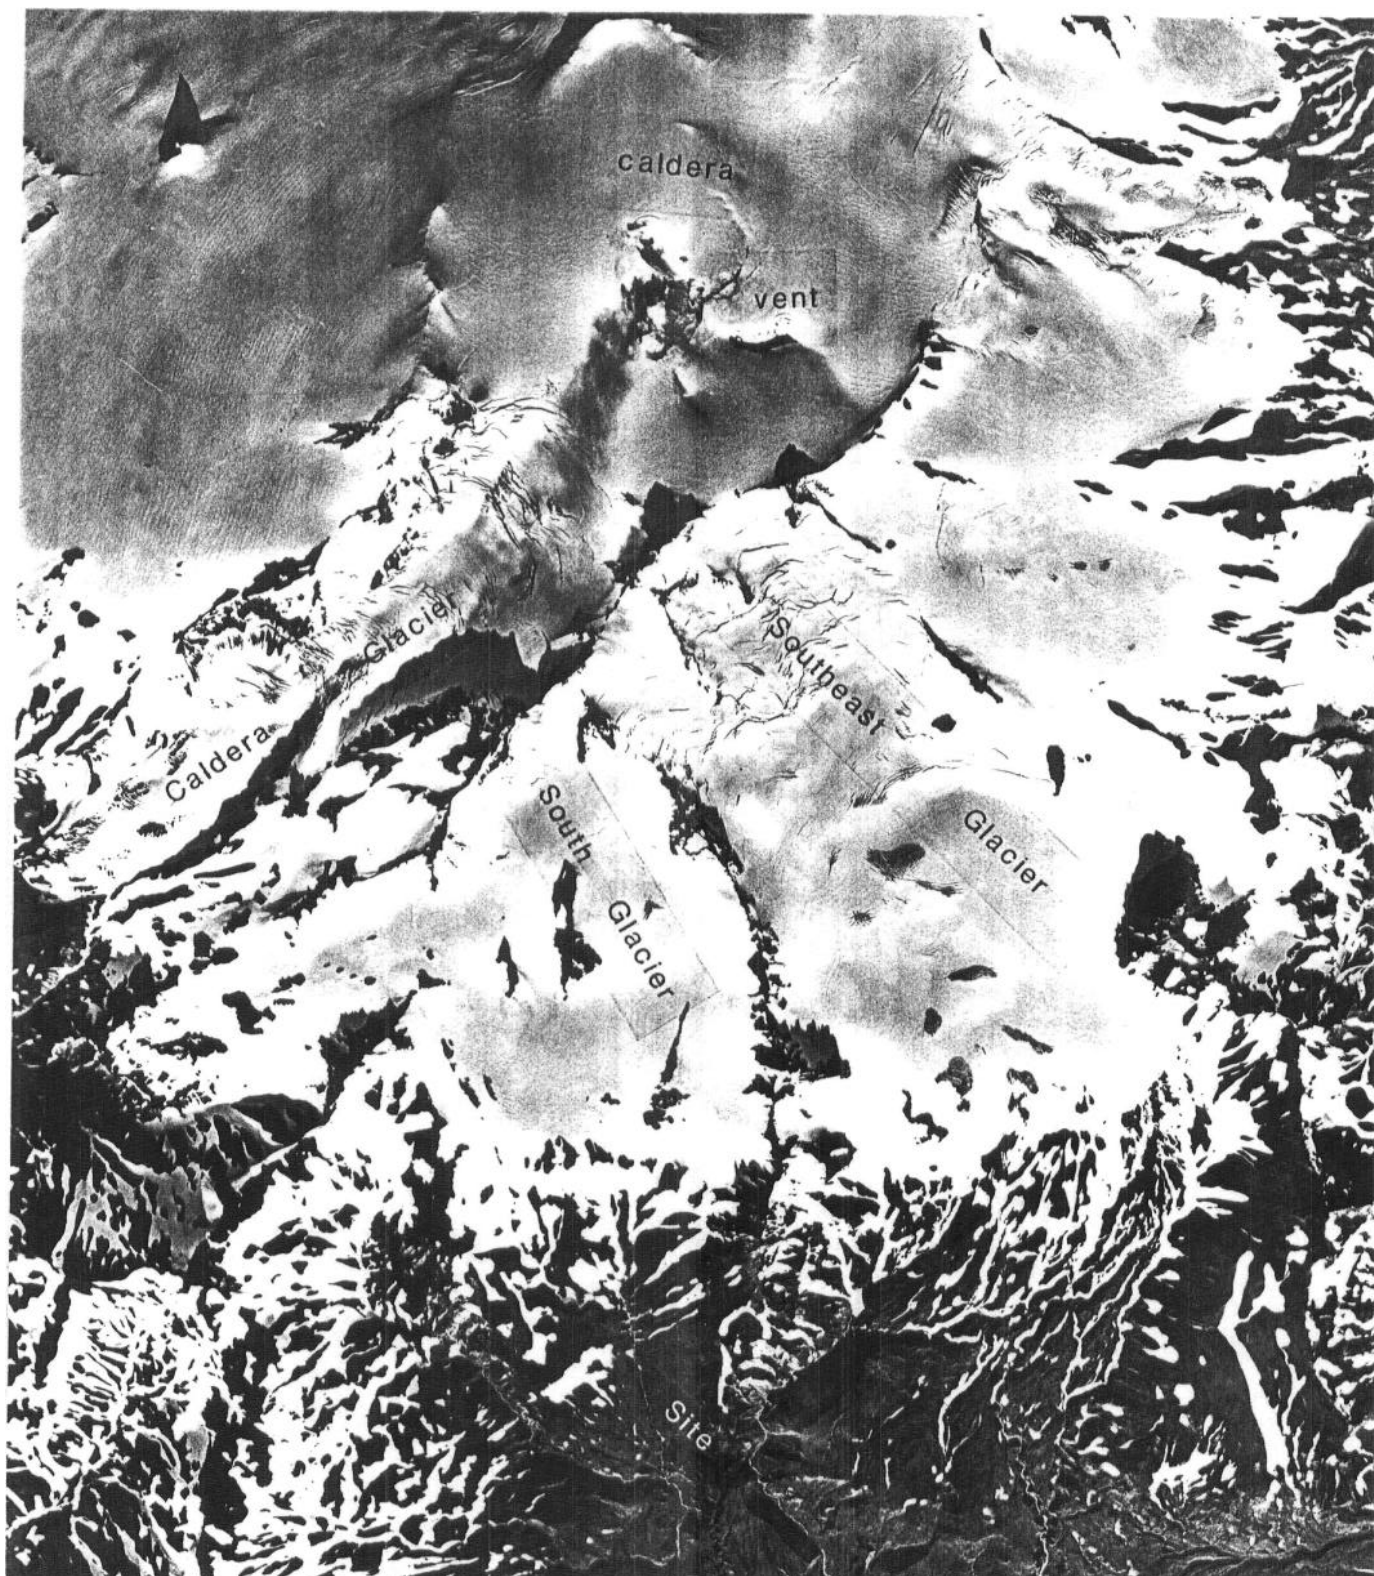
Figure 1. Aerial. photo of Makushin Volcano shows summit caldera with vent near center; Caldera Glacier flowing to SW; South Glacier, Southeast Glacier, and geothermal well site. (North Pacific Aerial Surveys photo - 2 Aug 82)

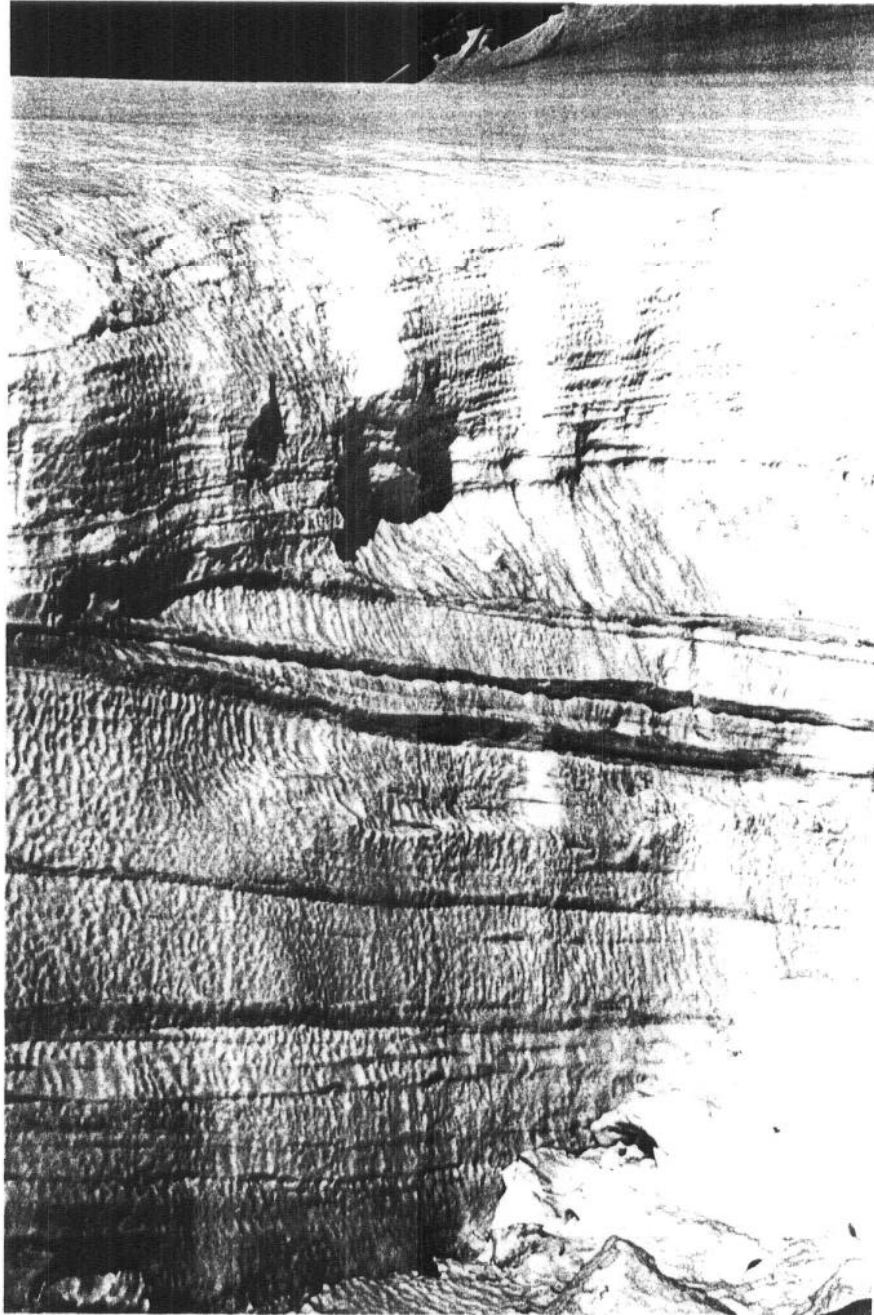
Figure 6. Southeast Glacier 1985-86 accumulation layer about 6 feet thick cover older firn at extreme western edge, near a local ablation zone.

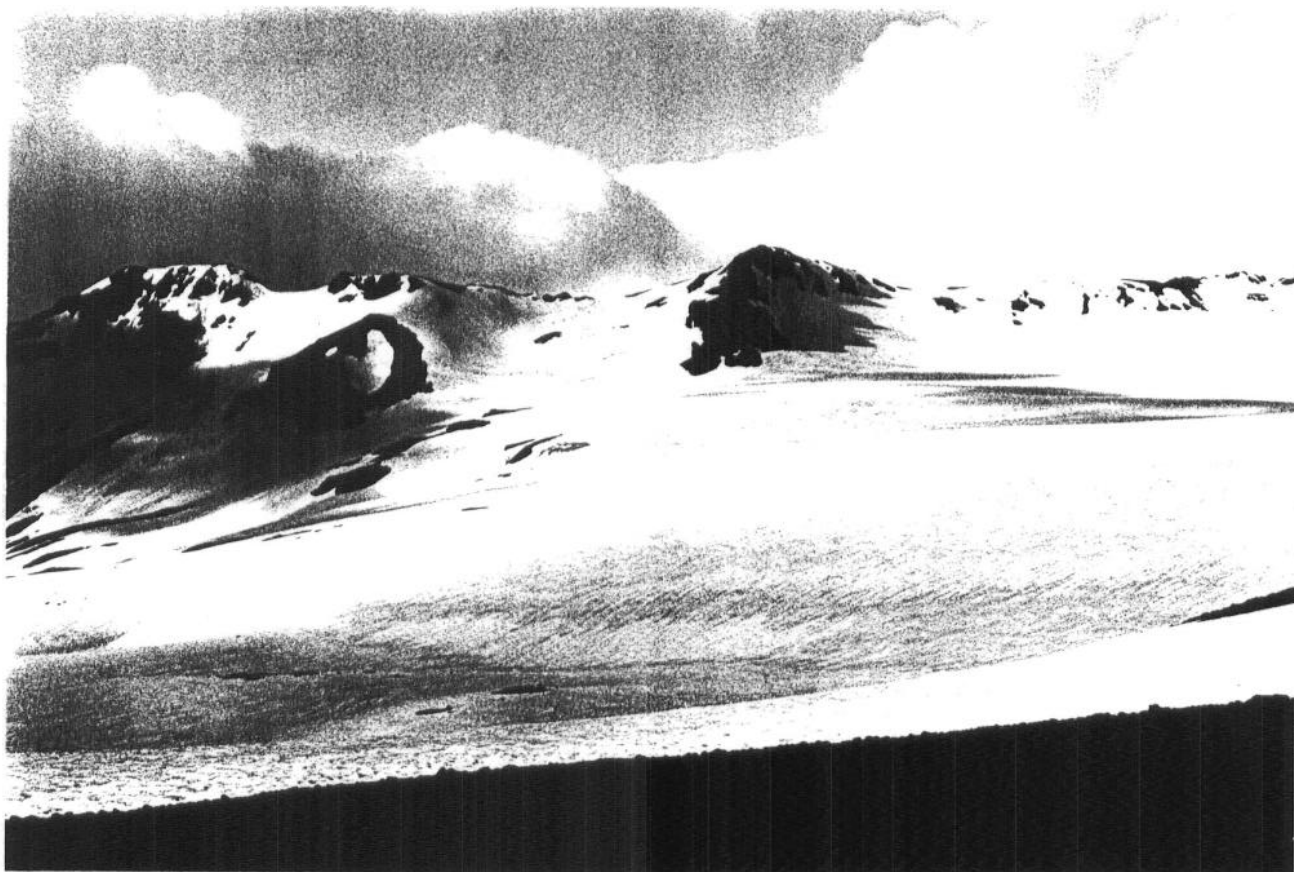
Figure 7. Southeast Glacier terminous is gentle and uncrevassed, typical of a glacier with negative mass balance (receeding).

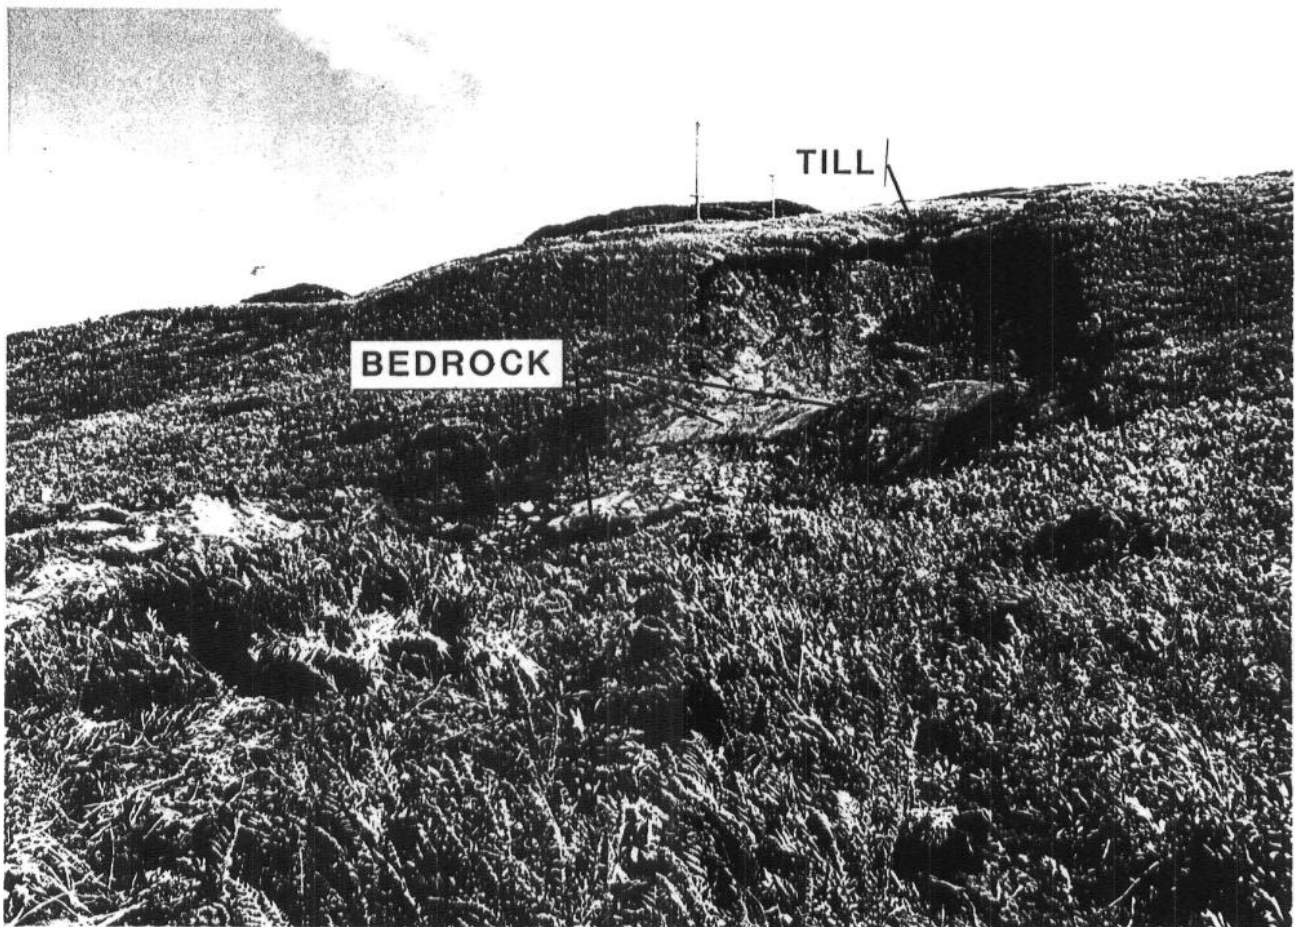
Figure 2. A view taken on 12 July 1986 of one of the many 8 November 1985 Unalaska landslides, which occurred during unusually heavy rains. This landslide is in the Unalaska Valley near Unalaska.1986.

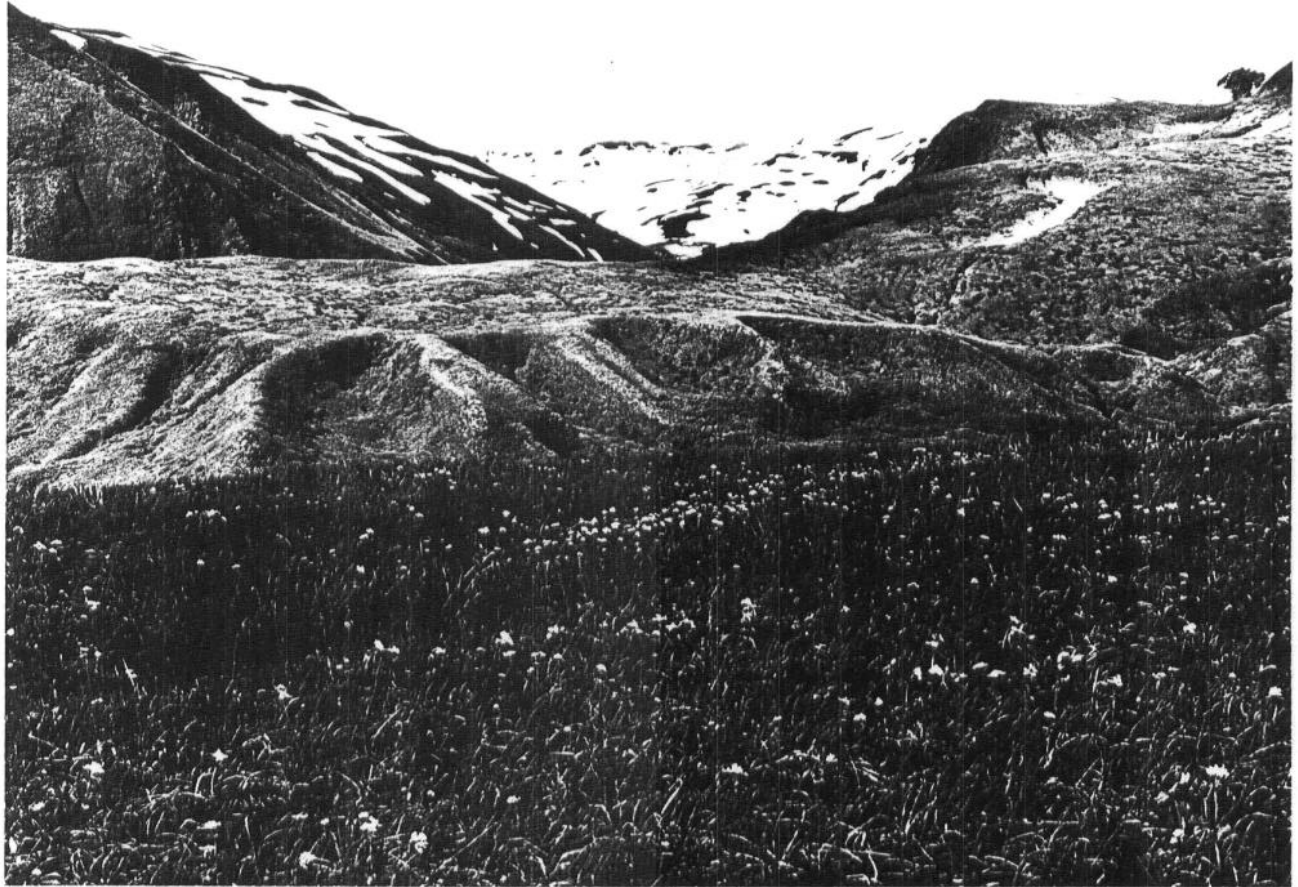
Figure 3. Numerous till failures can be seen in this view, which is to the south from the upper part of the Makushin (Broad Bay) Valley near its canyon.

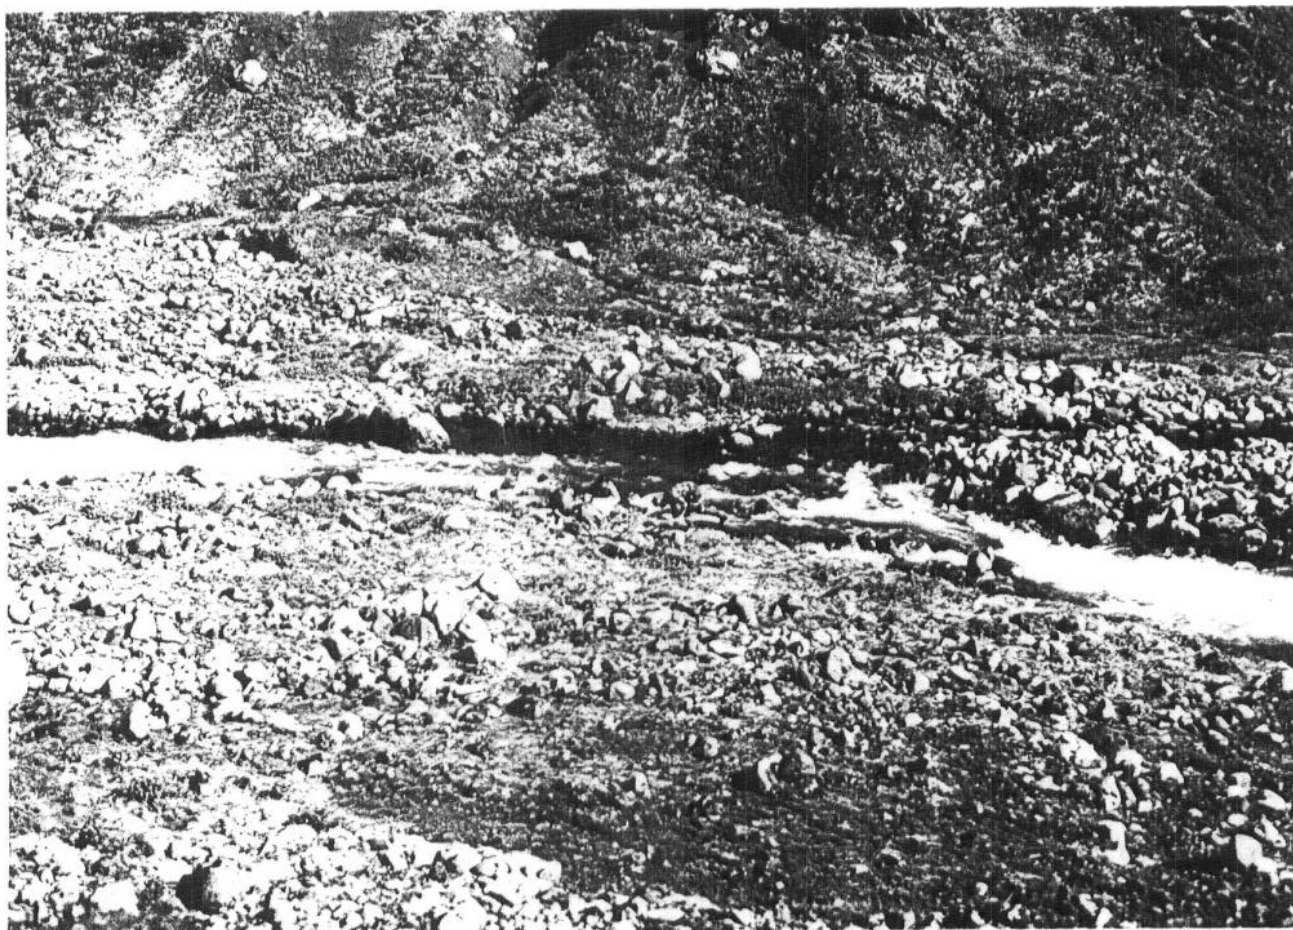
Figure 1a. Fox Canyon Creek (Site 1) at gage site near confluence with the upper Makushin Valley River, July 1986.

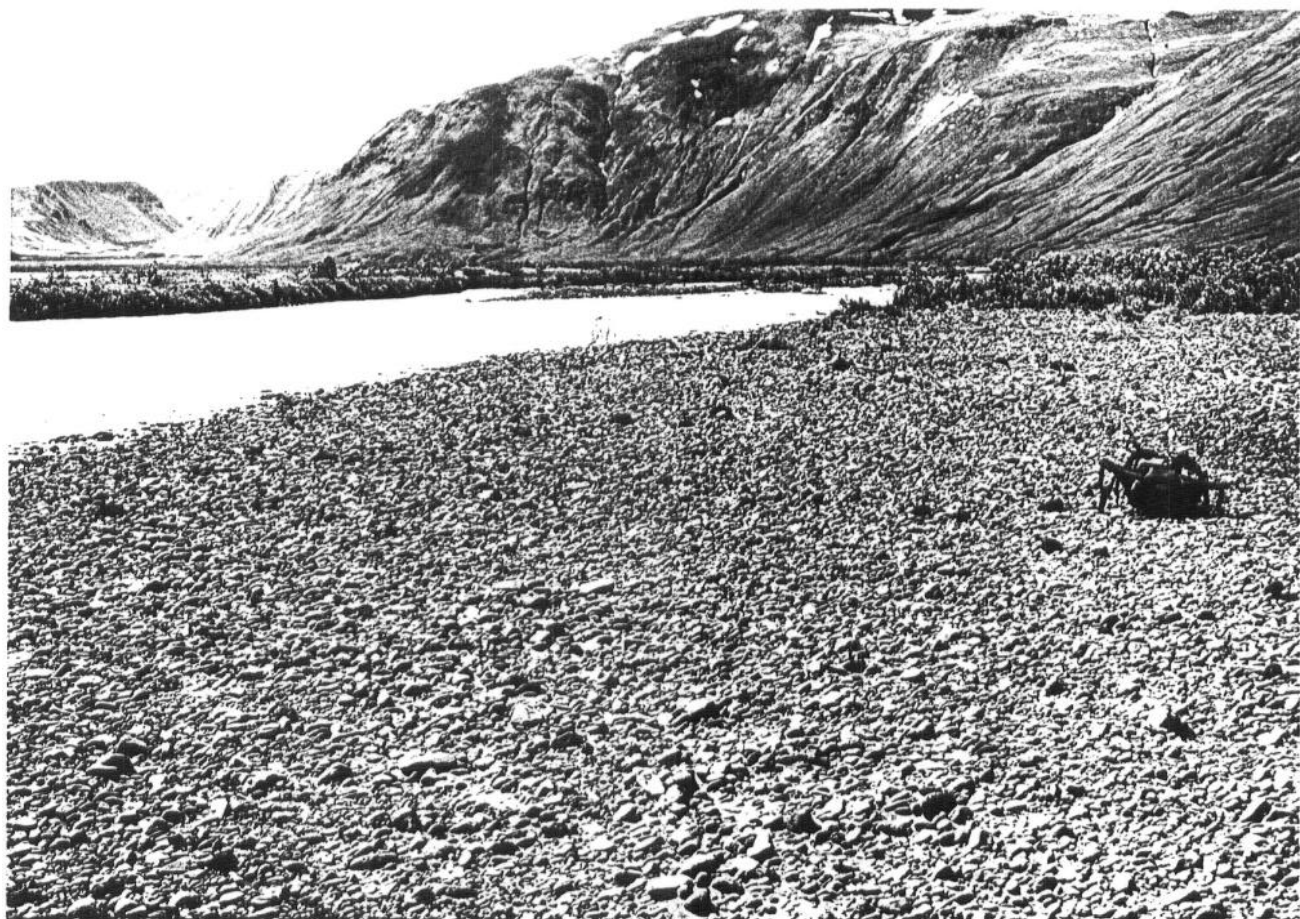
Figure 1b. Lower Makushin Valley River near mile 4.2, looking upstream, July 1986.

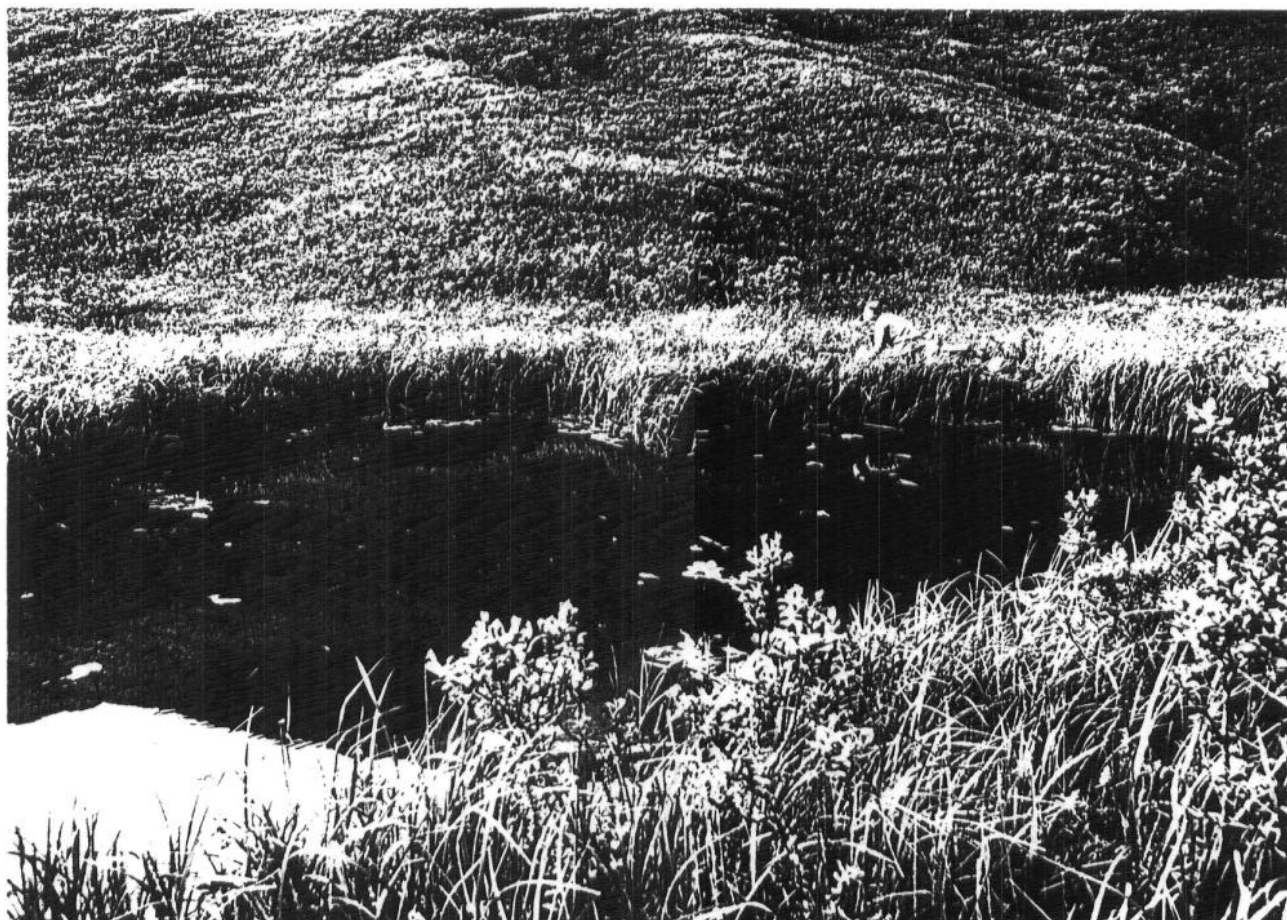
Figure 1. A view taken 15 July 1986 of pond 1, which is about 25 feet long and about 20 feet wide. Mary Maurer is unpacking field water-sampling equipment on the south side of the pond. The bottom of the pond consist of organic rich muds, and has three 7 foot deep depressions that were formed by spring upwellings.

These ponds ranged from just 7 to 8 foot deep 2.5 foot diameter features, as observed in the pond 1 region, up to 25 foot deep 150 foot diameter features, as observed in the pond 5 region. Usually several ponds would occur in close proximity, being fed by springs at their bottoms. On the edge of the Makushin Valley floor, several ponds were actually part of landslide depressions and were being feed by groundwater springs just **upslope**, as observed at ponds 2, 4, and 5. In these cases, either bedrock or tills were exposed at the site of the spring. Spring flows or upwelling appeared to be normally less than a liter per minute for individual springs. Any gas discharge, which is common for warm or hot springs, was absent in all Makushin Valley springs. Figure 1 is a view of pond 1, which is fed by three major groundwater springs at deep depressions in the pond. Figure 2 is a view of pond 4, which is fed by small springs from the hill to the right as well as by springs from the bottom of the pond.

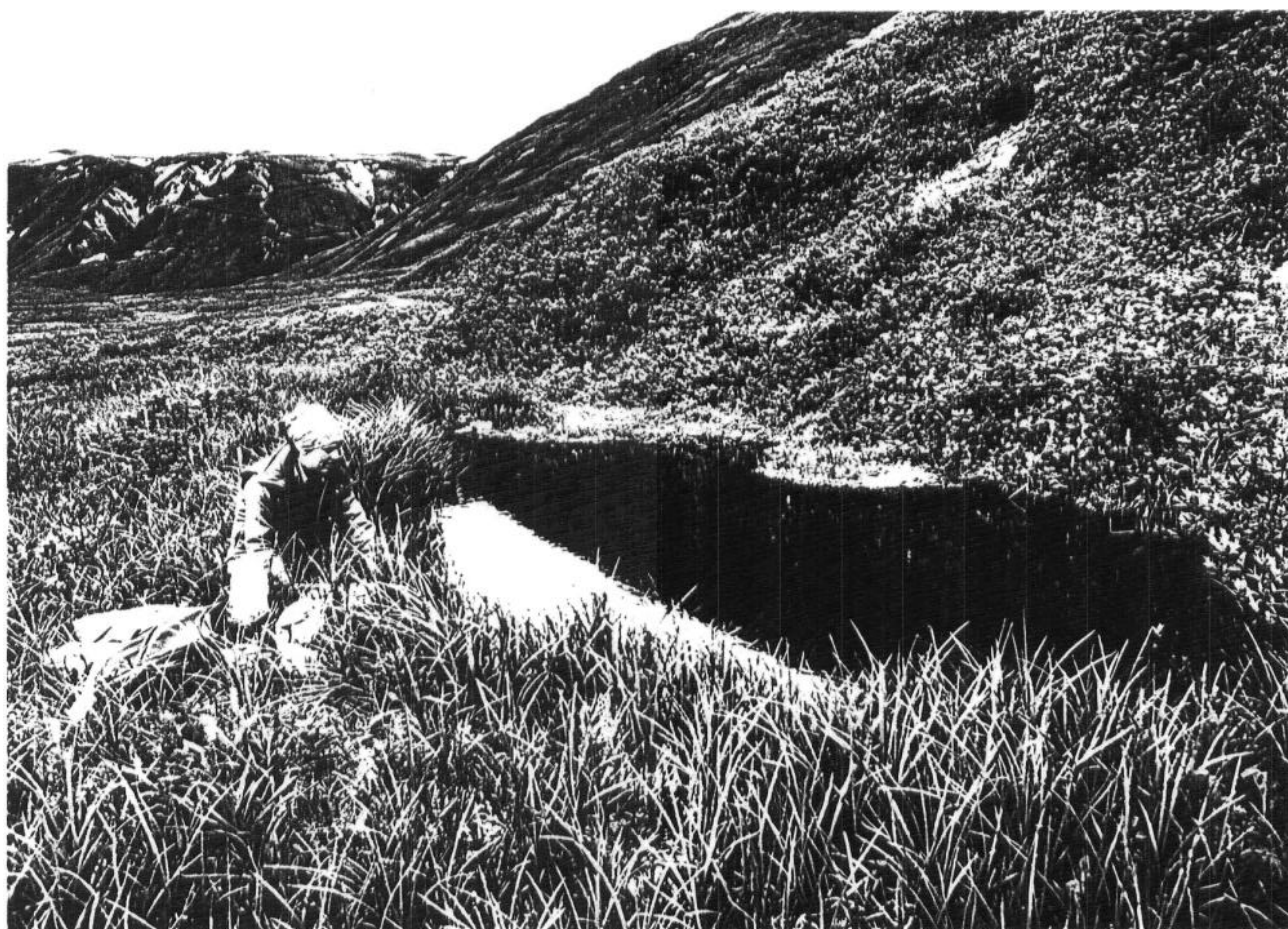
Figure 2. A view taken 15 July 1986 of pond 4 **with** Mary Maurer to the immediate left.

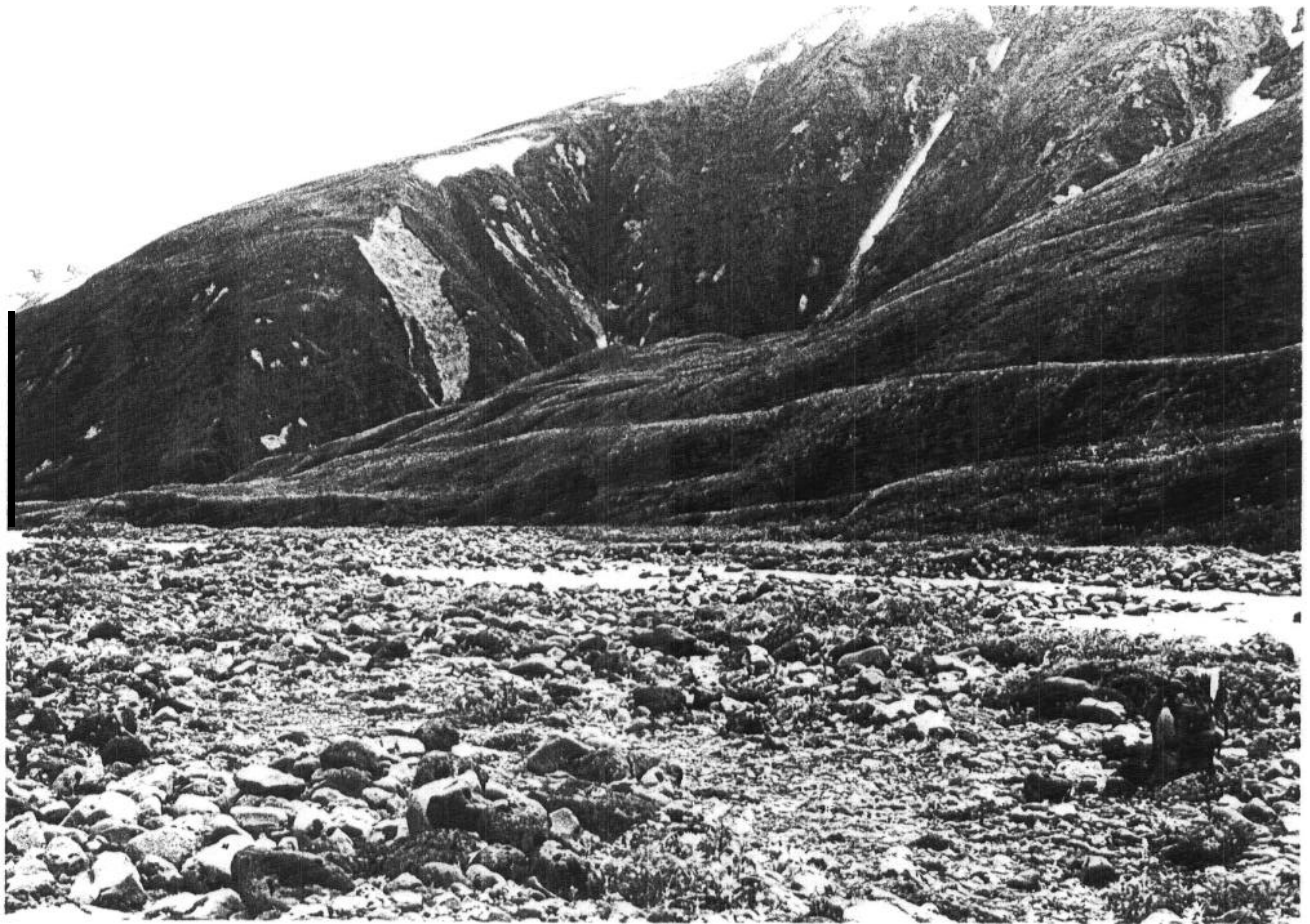
Figure 7. Typical stretch of the Makushin River valley floodplain, here near MS-17. Note backpack at right for scale.

Selected particle size analyses are provided in figures 1 through 6. These should only be considered as representative and far more exhaustive analyses would be required prior to final material site selection. Figures 7 through 12 are a series of representative photographs of the physical expression of some of the materials sites.

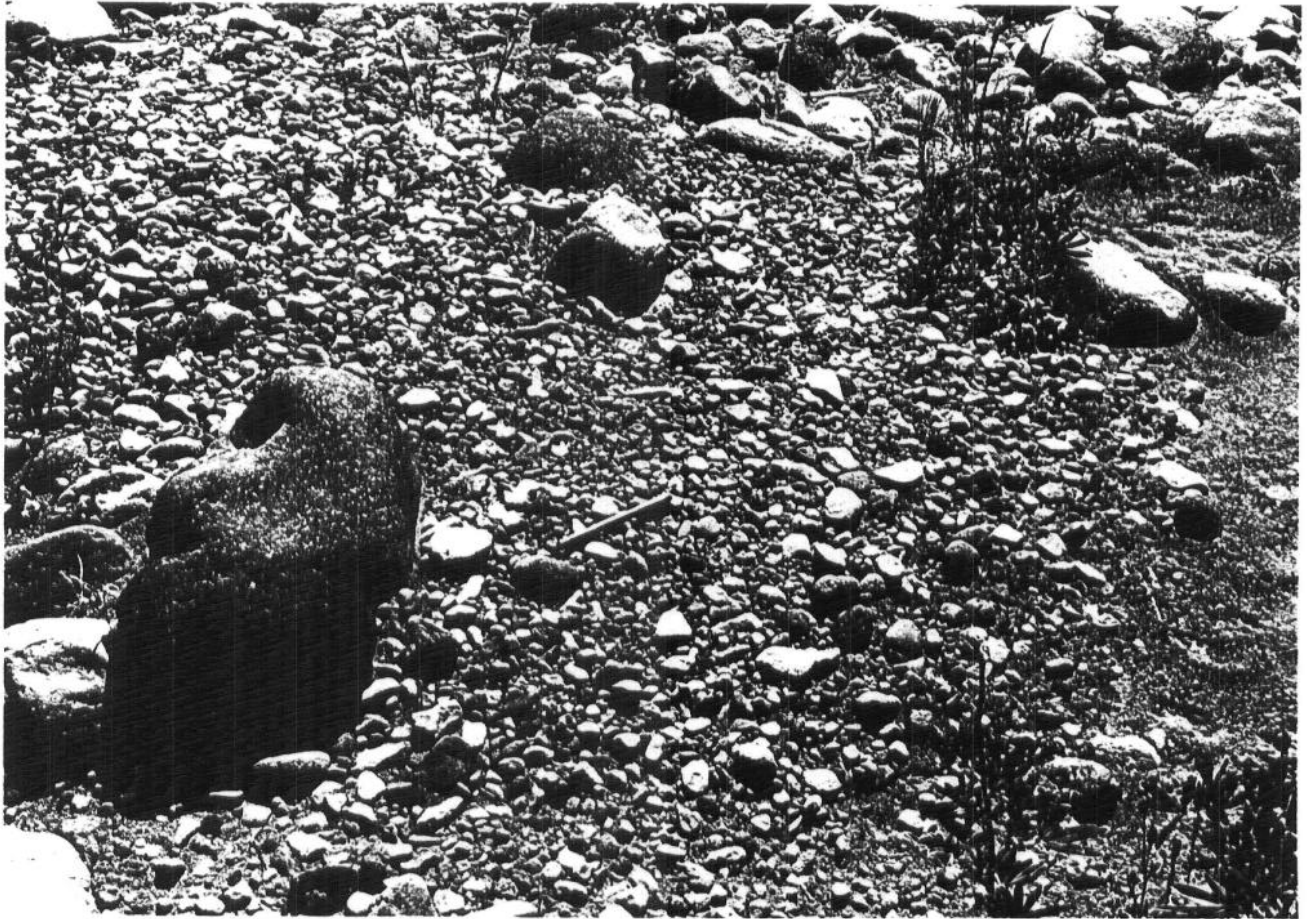
Figure 8. Close-up view of typical Makushin River floodplain sandy gravel, here near MS-18. Pencil in foreground for scale.

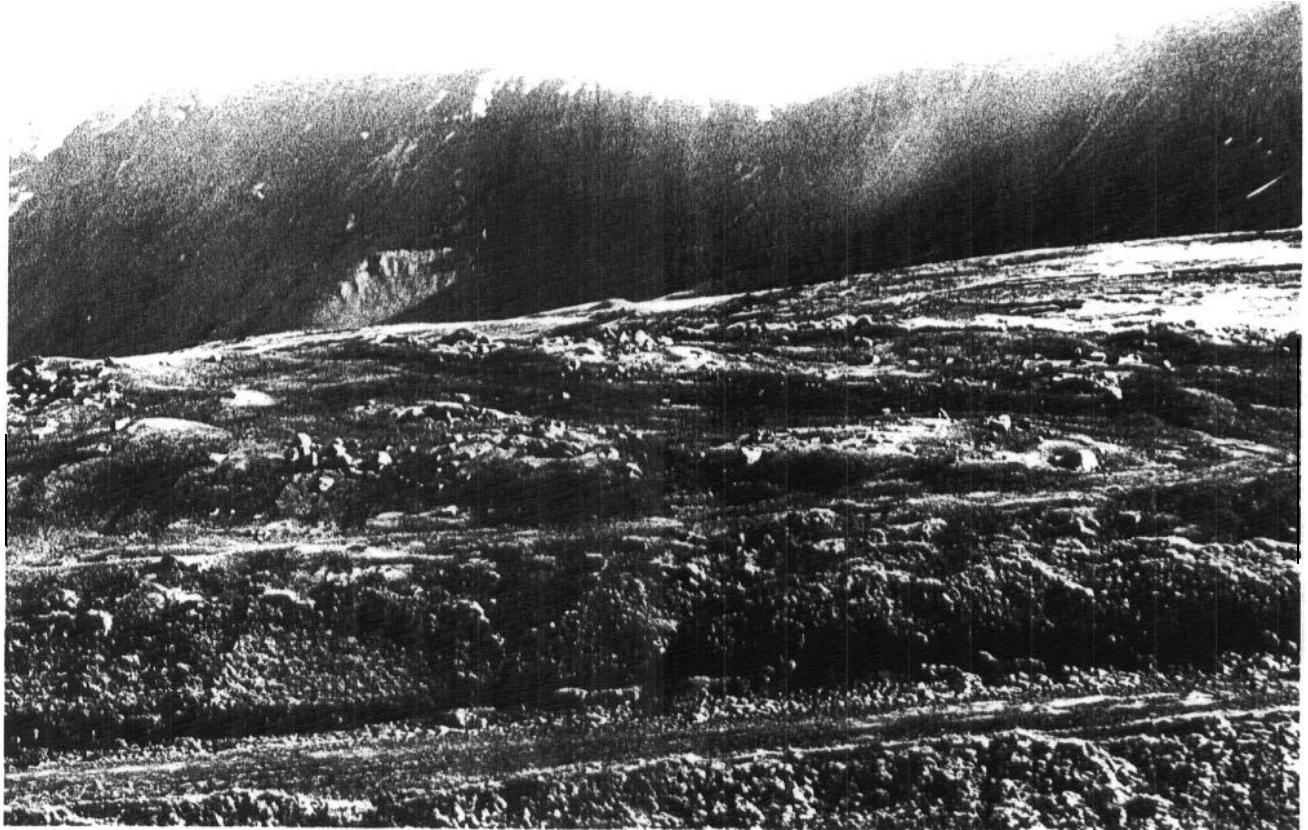
Figure 9. Low altitude oblique aerial photograph of Driftwood Bay road (bottom) showing the distribution of upland pyroclastic deposits commonly containing lapilli (gravel). Also note the scattered distribution of loose volcanic boulders in the pyroclastic blanket, the larger ones being greater than 1 m diameter. Photo near MS-3.

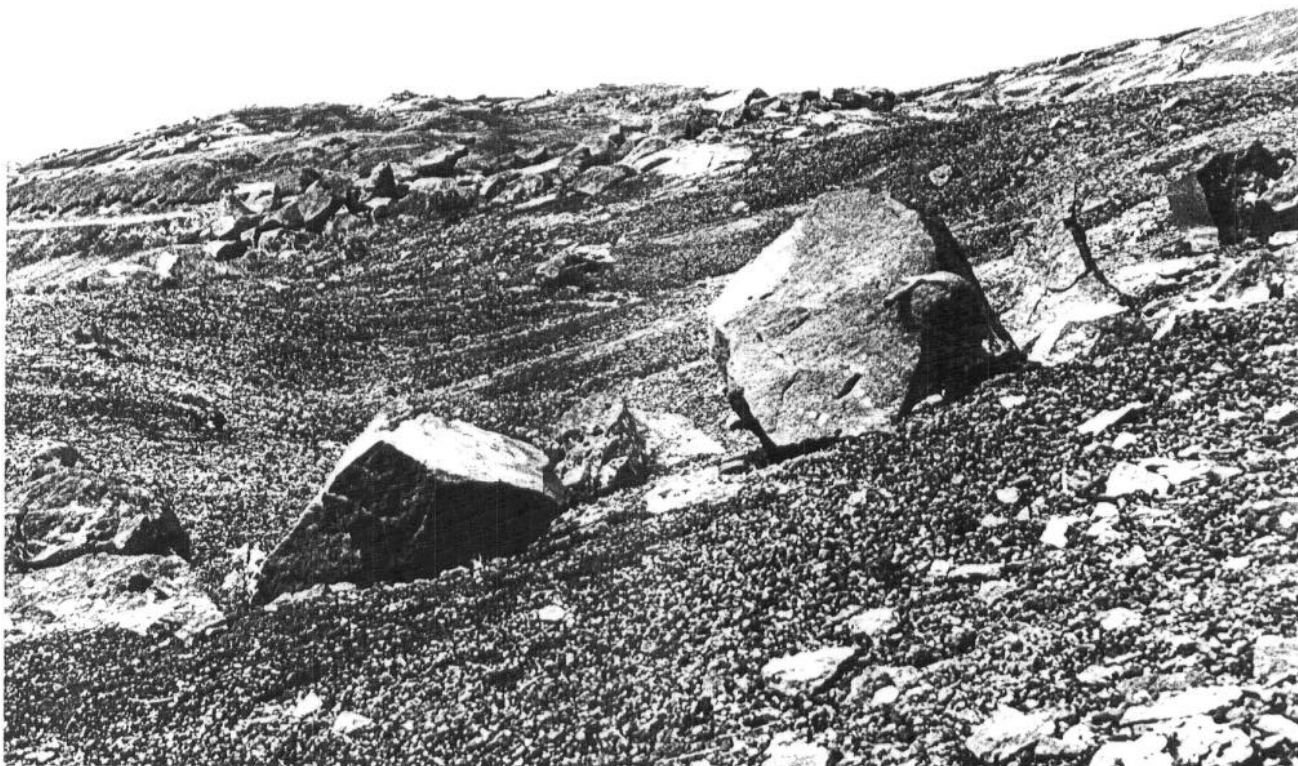
Figure 11. Andesite blocks being exhumed from pyroclastic lapilli-ash matrix at MS-7. These angular blocks occur immediately off of the existing road and could be easily loaded for use elsewhere as rip-rap. Note hammer on boulder for scale.

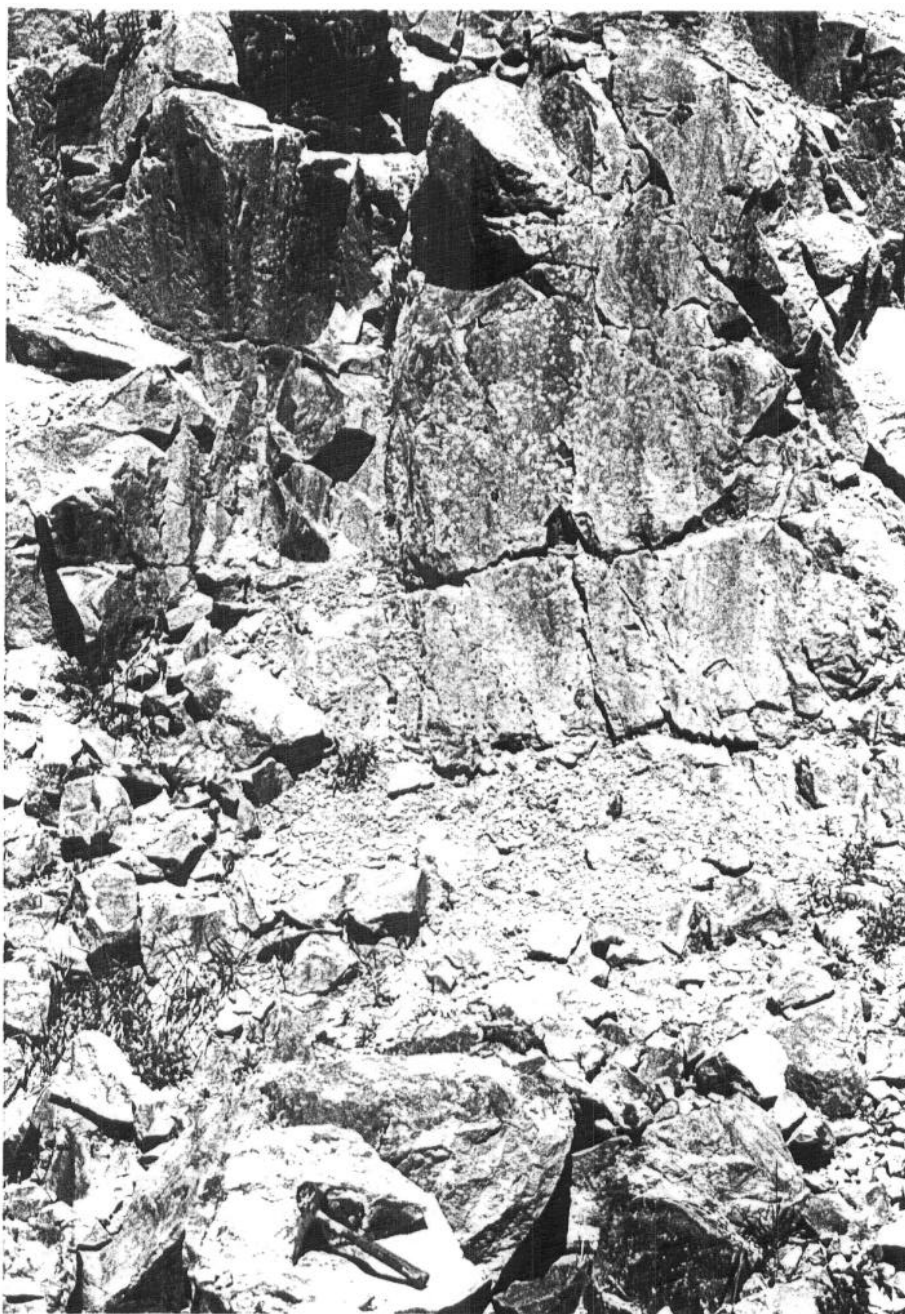
Figure 12. Exposure of blocky andesite at MS-12 suitable for rip-rap rock source. The exposure is on the existing Makushin-Driftwood road. The rock has a widely-spaced orthogonal joint system and textural uniformity ideal for construction stone quarry operations. Note hammer in foreground for scale.
